Continuing Airworthiness Notice – 71-002 issue 1

Eurocopter EC 120 B Harness, Generator Box Master P/N C243A2901101 – Inspection

19 December 2018

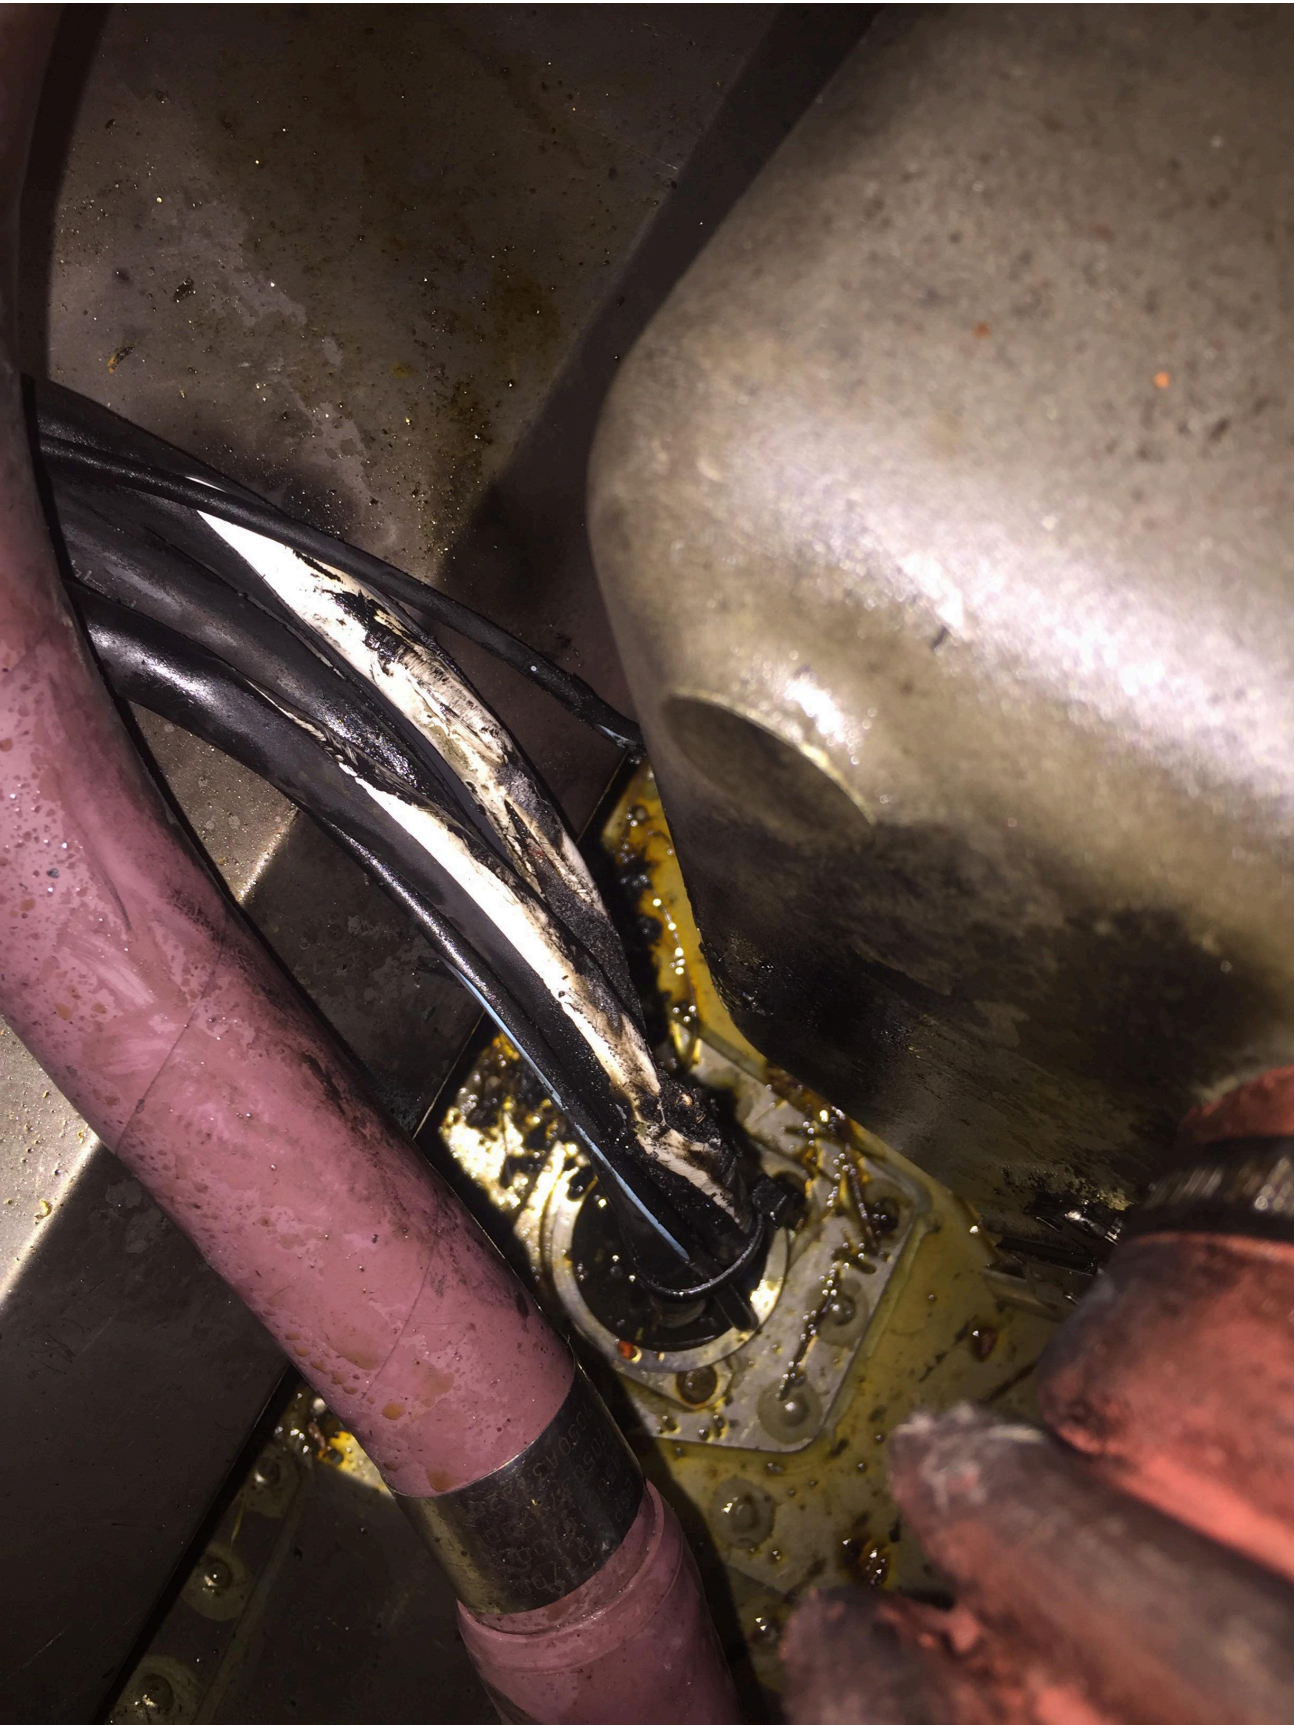
Upon further investigation the starter harness was found with significant internal and external arcing damage with sufficient separation from surrounding components in the area. The wear noted within the harness indicates the defect could not be seen without physical separation of the harness and an internal inspection. The damaged area of the harness is in an area obscured by the engine, the gearbox and the starter/generator. With reference to the two photographs provided in this CAN, the harness was generally in a good condition. The heat shrink deformation and conductor exposure on the outside was as a result of the incident.

Photo 1: Plan view of the area where the generator harness is located (i.e. view from above)

The CAA strongly recommends that operators/maintainers of affected helicopters inspect Harness, Generator Master Box P/N C243A2901101 and the engine oil sump for chafing damage in the concealed area identified in this CAN and in accordance with Eurocopter SL 1706-24-05. Inspect the starter generator harness clamps for condition and security. If any defects are found, accomplish corrective actions, before further flight.

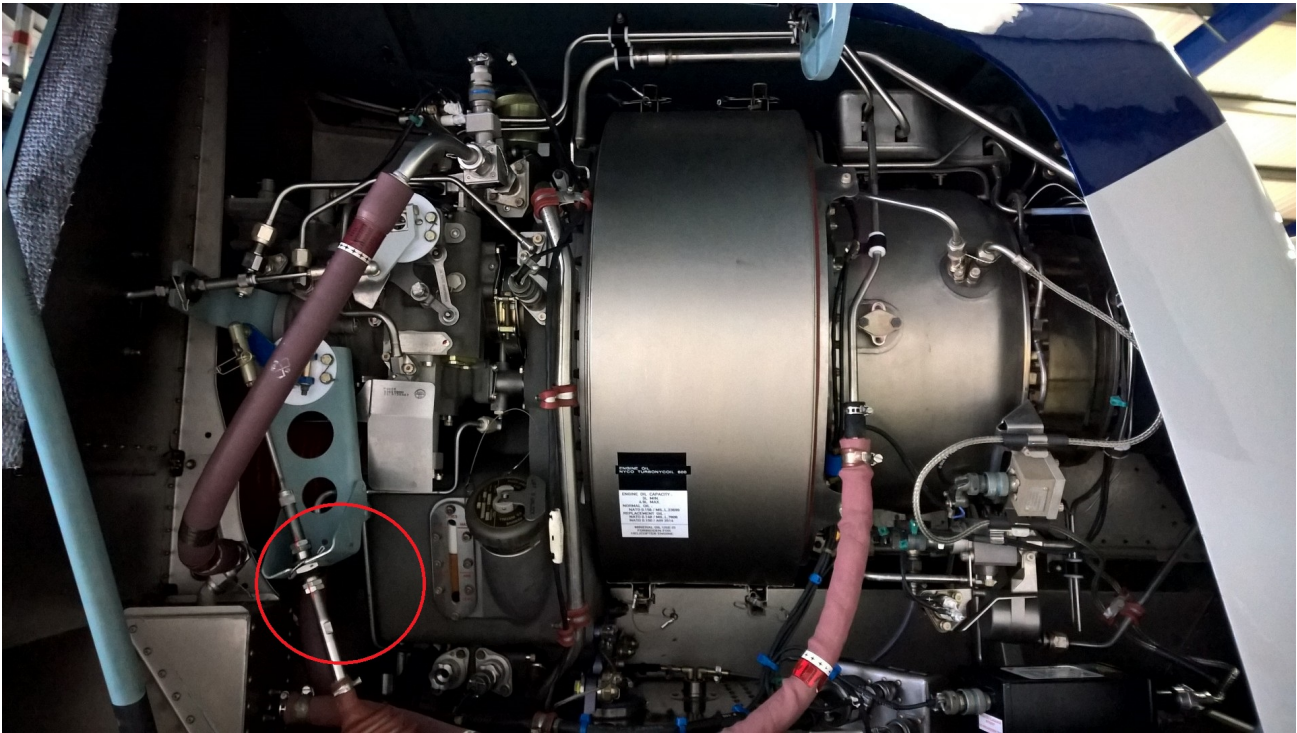
Photo 2: Side view of the engine and the area where the generator harness is located.
