# VECTOR

*Pointing to Safer Aviation*

## Circuit Breakers

# Circuit Breakers – How Well Do You Understand Them?

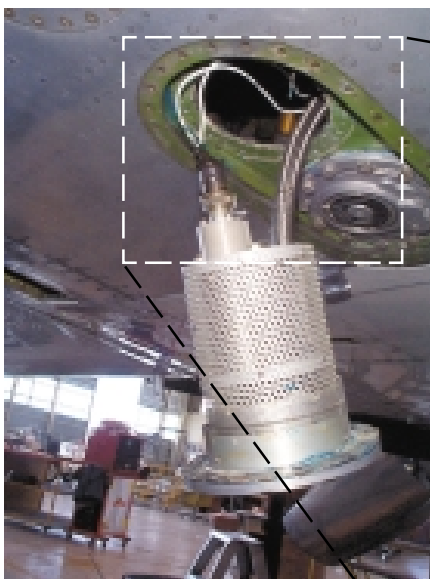
*Chafed fuel booster pump wiring found inside the fuel tank of a Fairchild Metroliner following an emergency AD inspection.*

the booster pump circuit breaker repeatedly tripped in flight. The chafed insulation caused arcing and could have provided an ignition source inside the fuel tank. The fuel tanks of six aircraft in the fleet were inspected by the operator's maintenance provider, and all were found to have some evidence of chafing to the boost pump wiring (in one case there were signs of arcing).

The CAA was alerted and an emergency AD (applicable to all New Zealand-registered Metroliners) promptly issued; this required the immediate inspection and removal of each boost pump to repair or replace any suspect wiring. The AD also required the pumps to be reinstalled in such a way that adequate clearance between the wiring and the fuel valves could be assured, and that they be inspected for chafing thereafter whenever the boost pumps were removed.

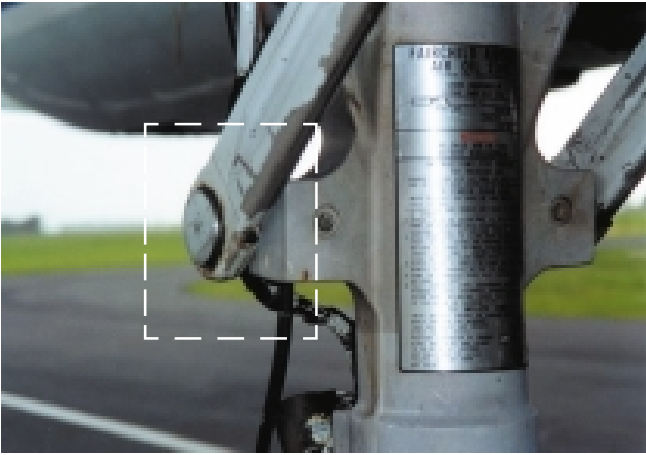
A Fairchild Metroliner undercarriage drag link.

In a further example, an AD was prompted by the failure of a main landing gear drag link on another New Zealand-registered Metroliner; this resulted in a wheels-up landing following a training flight. Fleet inspections as a result of this occurrence revealed that other drag links were cracked, leading to the CAA issuing an AD to inspect all New Zealand-registered Metroliners.

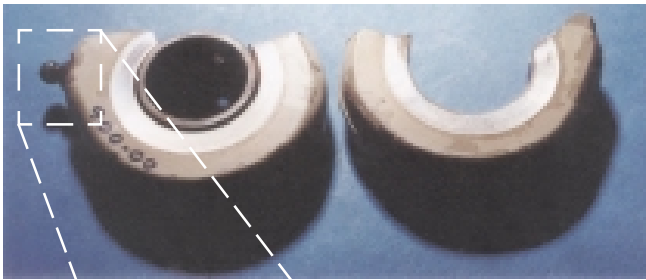
Failed drag links.

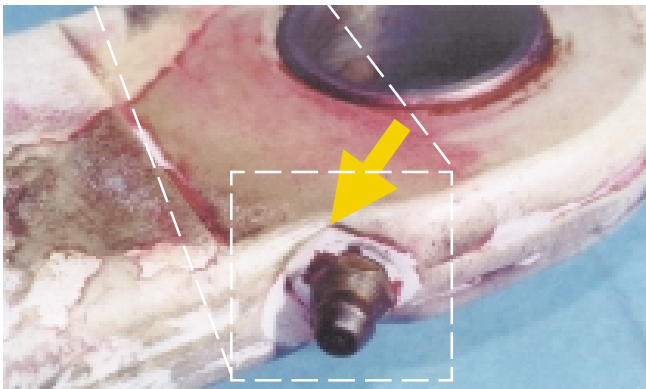
The arrow indicates the position of a hairline crack (difficult to see here) that was found propagating from the milled area of a Fairchild Metroliner undercarriage draglink during an emergency AD inspection.

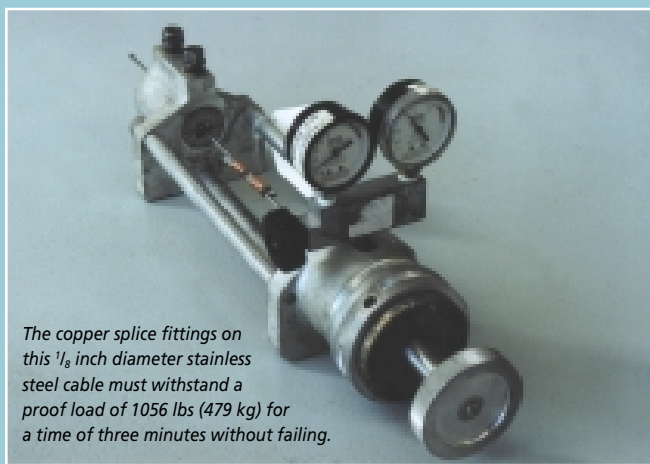
The copper splice fittings on this 1/8 inch diameter stainless steel cable must withstand a proof load of 1056 lbs (479 kg) for a time of three minutes without failing.

To our surprise the cables all started to pull out of the swage fittings at about **one quarter** of the required test load.

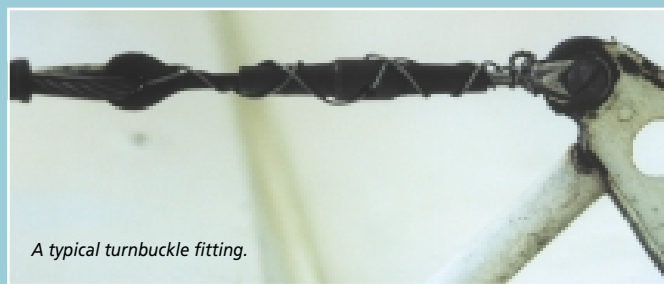
A typical turnbuckle fitting.

It was discovered by chance that this particular item had been incorrectly assembled using a cable eye-end fitting one thread size smaller than the turnbuckle barrel. The tips of the threads only were engaged. Likely disaster was only averted by good lockwiring. Had the unit been one of those which is locked by wire clips, not lockwire, it would certainly have pulled apart!
