# VECTOR

*Pointing to Safer Aviation*

## Overloaded!

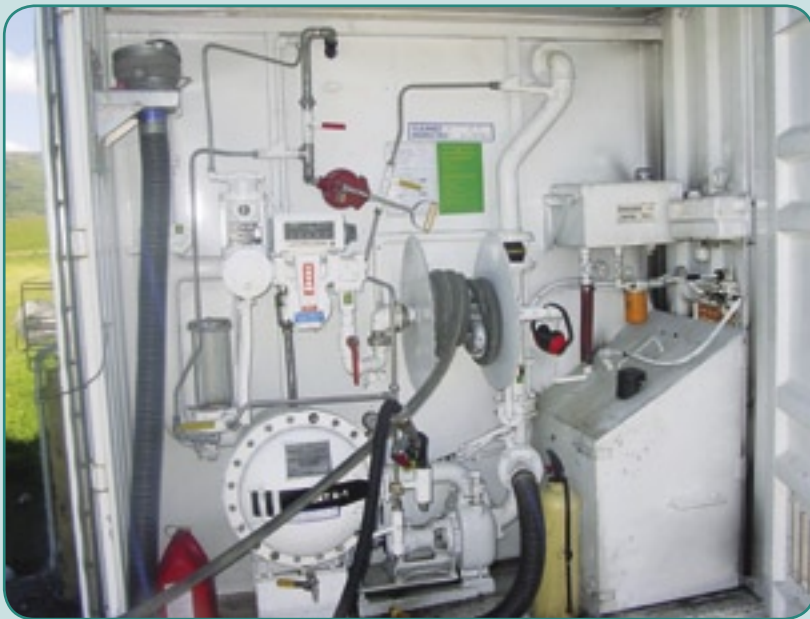
*The high-flow fuel pump system used to refuel the incident aircraft. This system is capable of delivering fuel at a significantly higher rate than the standard fuel pumps found at most aerodromes.*

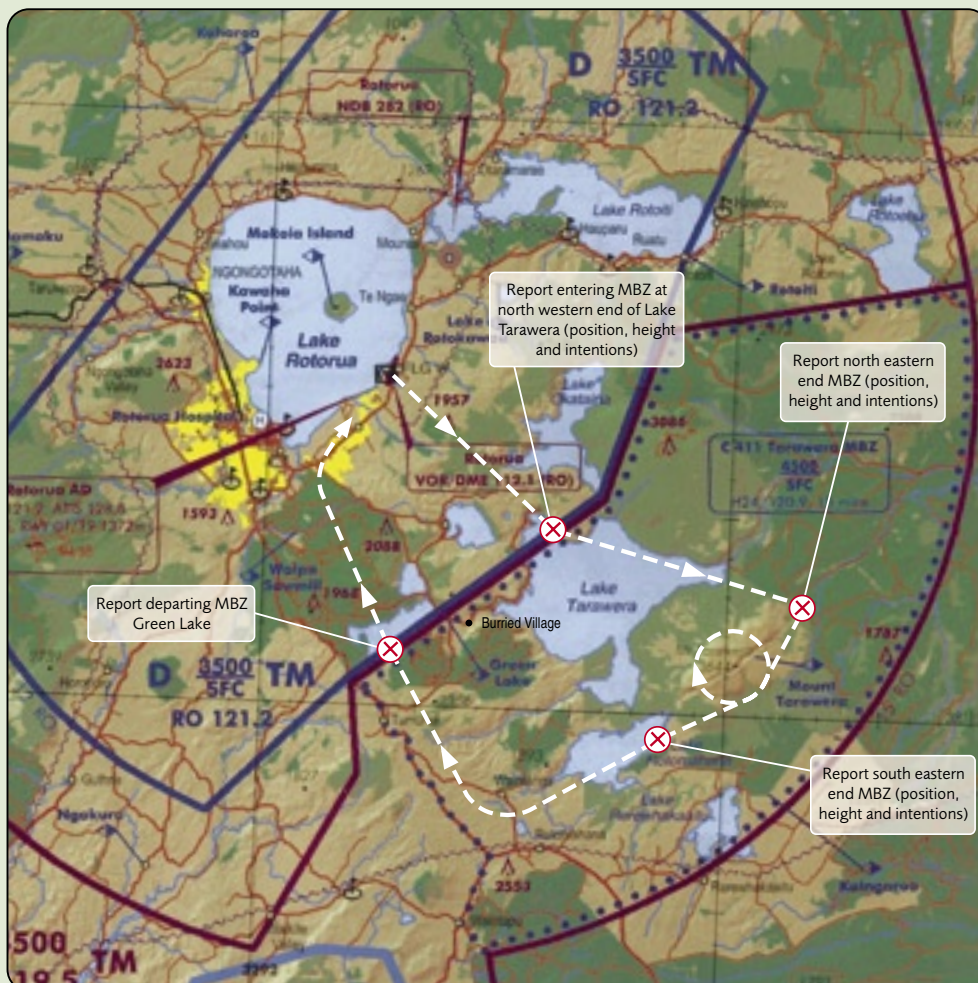
An example of the typical flight paths and position reports made by local flight-seeing operators. It is suggested that itinerant pilots wishing to go flight-seeing in the area, should follow these procedures to minimise the risk of a mid-air collision.
