vector

Winter Happens

Safety Promotion Unit of the Civil Aviation Authority of New Zealand, PO Box 3555, Wellington 6140.

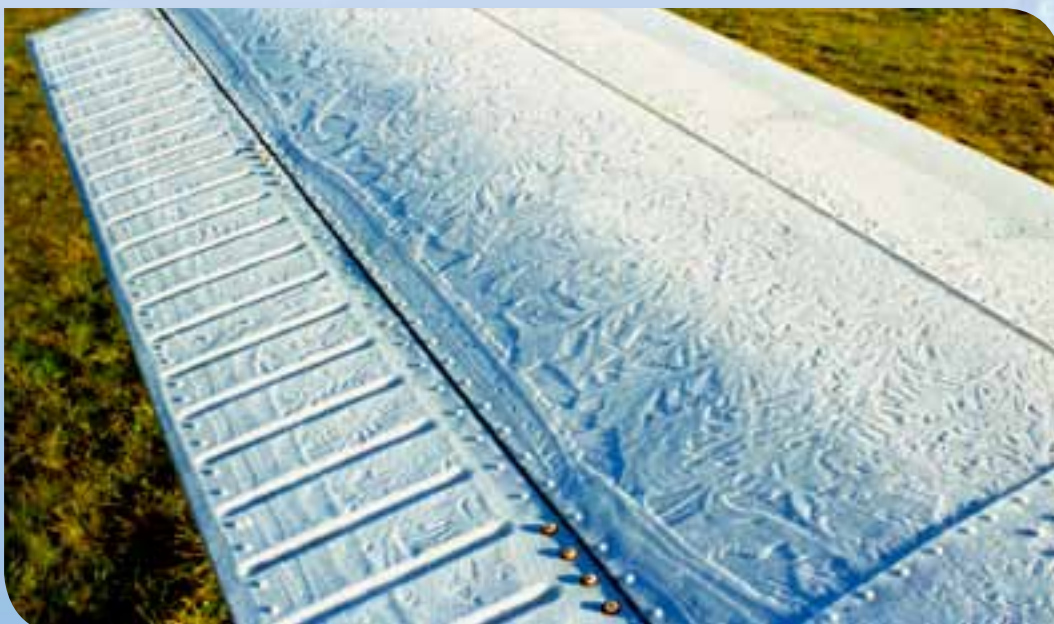
Spectacular frost patterns on a PA-38 Tomahawk wing
Photos courtesy of Paul Neame.

On an aircraft that has been parked out overnight, frost can be an insidious hazard. It takes only a light frosting on wings or rotor blades to degrade the boundary layer airflow, which is critical to lift development. Frost with the texture of medium-grade sandpaper can be enough to result in a stall after takeoff at what would be normal speed for a clean wing. Similarly, a heavy dew or rain that has subsequently frozen on the aircraft will affect the lifting ability of the wing or rotor, and may add significantly to the aircraft weight if not removed.

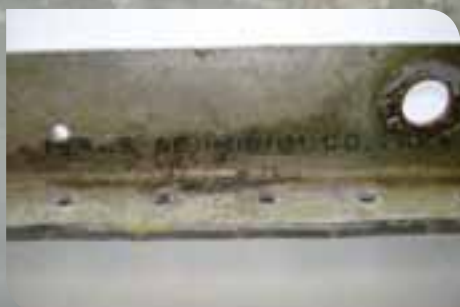
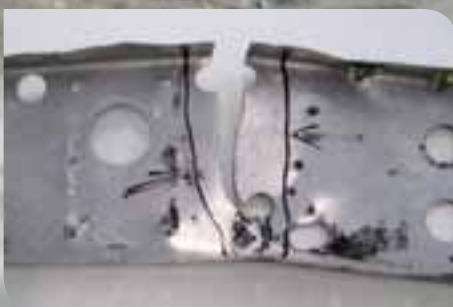
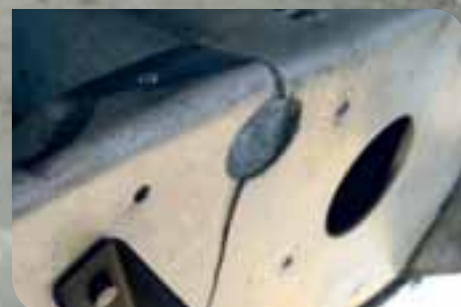
A selection of images of structural damage in Cessnas, that were all discovered during SIDs inspections.

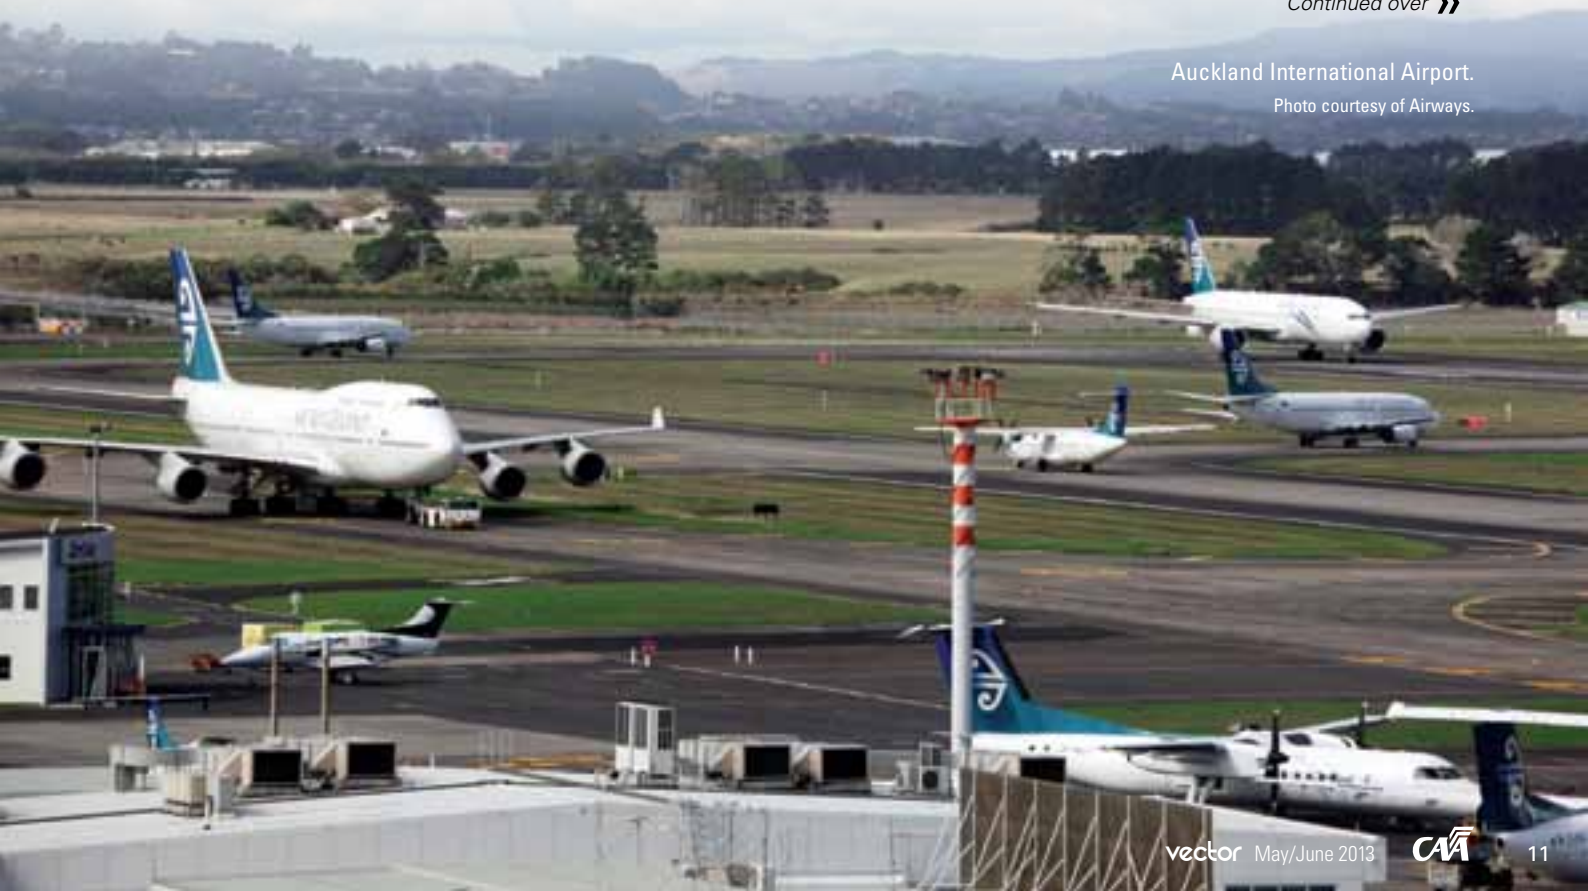
Auckland International Airport.
Photo courtesy of Airways.

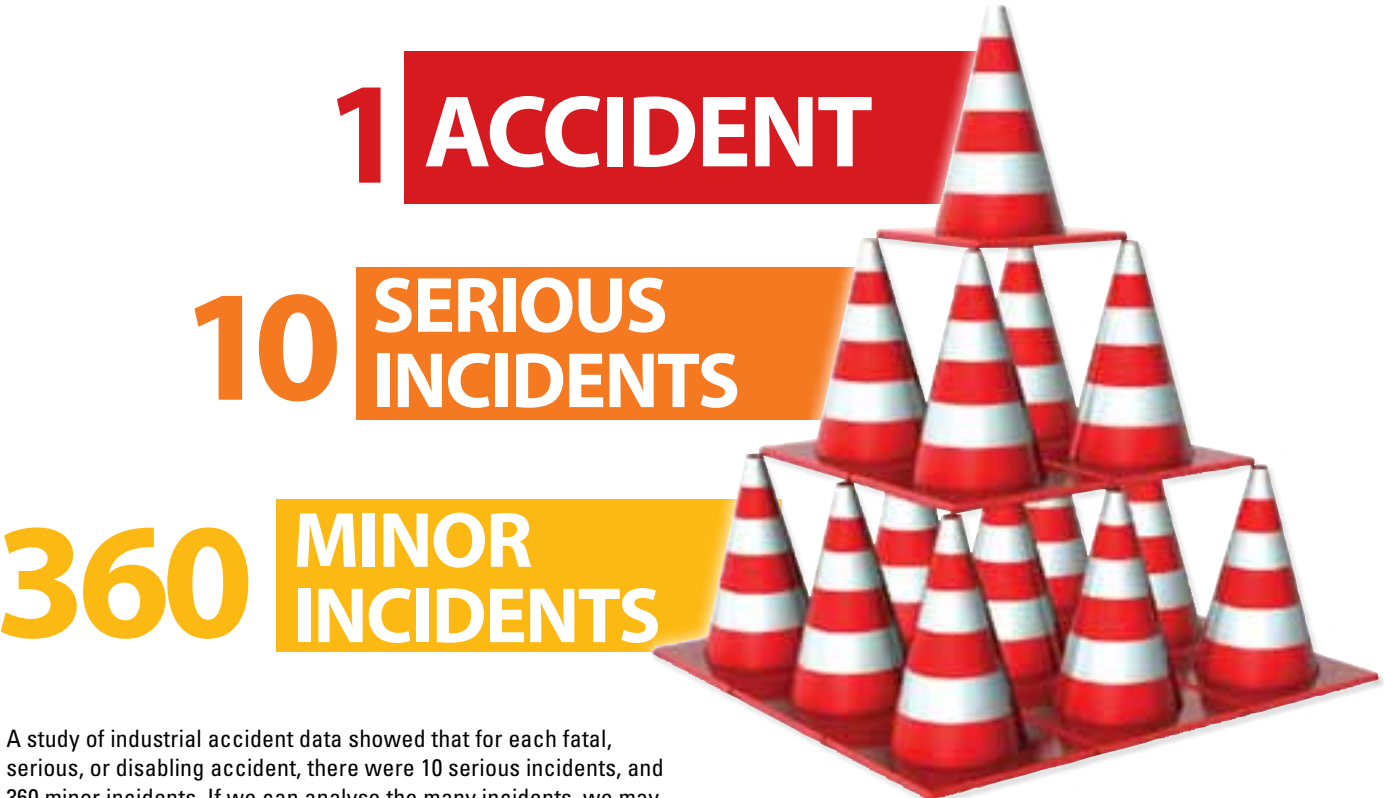
Accident/Incident Pyramid

A study of industrial accident data showed that for each fatal, serious, or disabling accident, there were 10 serious incidents, and 360 minor incidents. If we can analyse the many incidents, we may be able to put defences in place that will prevent a serious accident.

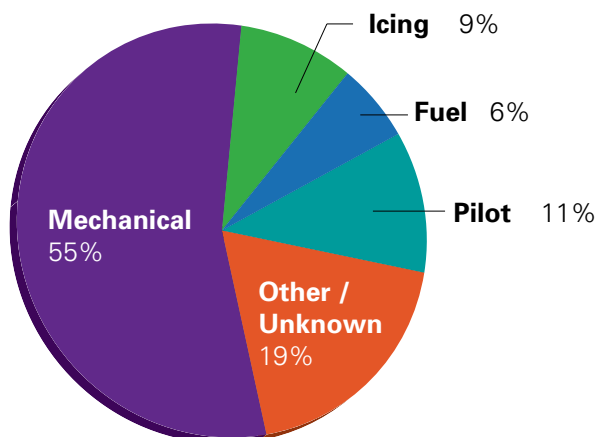
Graph of reported causes of engine partial power loss

As occurrences of partial power loss occur three times more often than a total power loss, your preflight planning should
